Manhole Inspection Summary

Manhole # S25AA_016MH

Location Address: **1218 LANVALE ST**

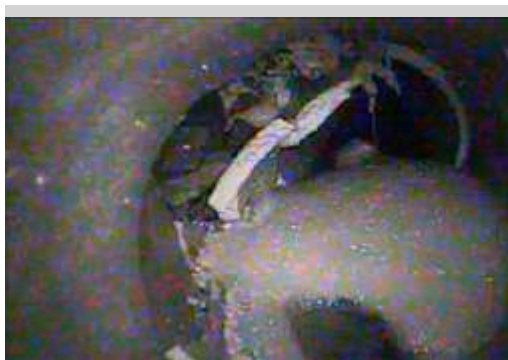
Defect 6

INSIDE O12 PIPE IS COLLAPSED

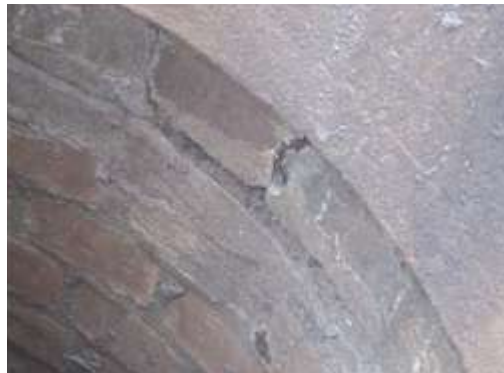
Defect 5

Condition: ☐ Sound ☒ **Cracked** ☐ Root Intrusion ☐ Loose Brick ☒ **Deteriorated**

CRACKED CHIMNEY

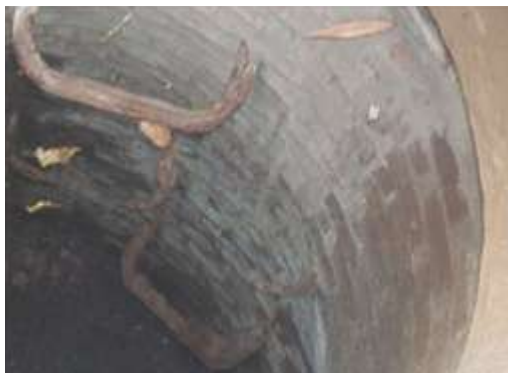
Defect 4

Infiltration: ☐ None ☐ Joint ☐ Cracks ☐ Mortar ☐ Roots ☒ **Wall**

Steps Count: **3** Missing: **1** ☒ **Corroded**

MISSING AND CORRODED STEPS AND INFILTRATION ON CORBEL

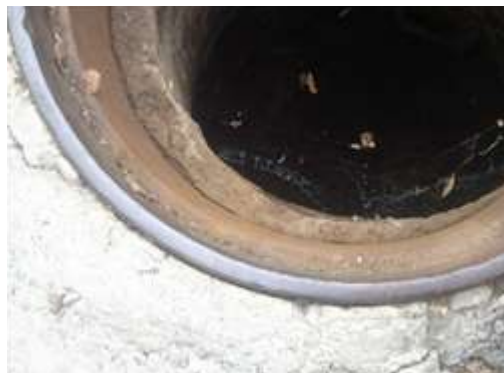
Defect 3

Frame Offset: **2** (in.) Condition: ☒ Sound ☐ Cracked ☐ Leaks

FRAME OFFSET

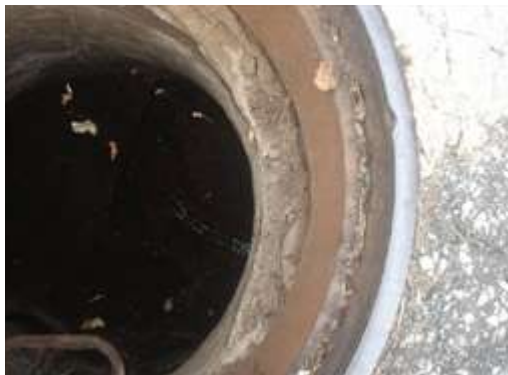
Defect 2

CHIMNEY DETERIORATION

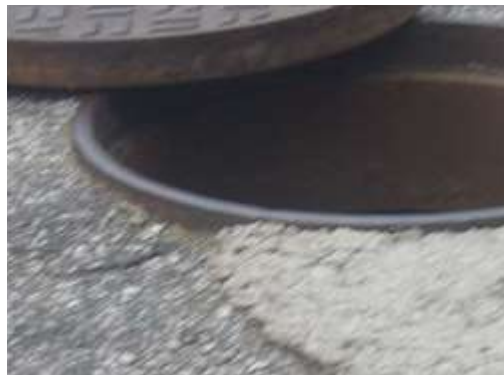
Defect 1

Cover Shape: **Circular** Diameter: **24** (in.) Length: (in.) Dist A/B Grade: **1** (in.)

GRADE ADJ.
